Engineer's Report for "FINGER LAKES STORAGE BRINE POND"

Town of Reading
Schuyler County, New York

Finger Lakes Storage, LLC

Prepared by:
C.T. MALE ASSOCIATES, P.C.
50 Century Hill Drive
Latham, New York 12110
518-786-7400
FAX 518-786-7299

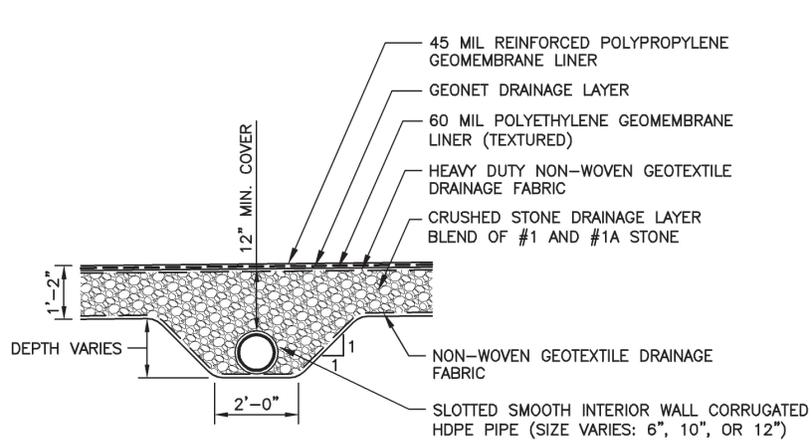
The impoundment will be constructed using the double-liner and leak detection system schematically shown below.

Typical Geomembrane Liner System Cross-Section at Underdrain Location

Permanent drainage of groundwater below the pond is necessary to guard against hydrostatic uplift of the liner system at times when the pond level is seasonally lowered to its lowest operating level (i.e. nearly fully drained). As shown in the detail above, the liner system across the base of the pond will be underlain by a drainage course of crushed stone that being a 14-inch thick layer of an equal blend of No. 1 and No. 1A sized crushed stone. Groundwater collected by this drainage course and the interceptor drains installed at the toe of the embankment's interior slopes will be directed to five (5) header pipes, three of which will be aligned along or very close to the pre-existing drainage swales discussed in Section 3.5. At the header pipe locations, the drainage course will be locally increased an amount equal to the outside diameter of the header pipes. Estimates of the groundwater flow these pipes may carry have been made and, for their design pitch, the pipe diameters shown on the drawings are capable of transmitting many times the estimated rates of groundwater flow. Accordingly this underdrainage system will guard against hydrostatic uplift of the liner system.

A 60-mil textured HDPE geomembrane will be installed above the drainage course but will be underlain by a heavy duty geotextile to separate the liner from the underlying drainage course of crushed stone and prevent it from being punctured by the same. A leak detection system consisting of geocomposite (geonet) will be installed above this geomembrane and itself be covered with the primary geomembrane, a 45-mil reinforced polypropylene (rPP) geomembrane. The upper (primary) geomembrane will contain the brine solution while the lower (secondary) liner will contain any potential leaks in the primary liner. The upper rPP geomembrane has been selected due to its flexibility in handling, excellent weathering characteristics and chemical/UV resistance and manufacturer's warranty period of 20 years. The lower textured HDPE geomembrane has been selected due to its enhanced sliding resistance over the heavy duty geotextile and its greater resistance to being punctured by the underlying crushed stone drainage course.

At four (4) locations across the base of the pond, the lower geomembrane will be locally depressed along where leakage collection pipes will be installed below the upper rPP geomembrane. The collection pipes along these lines will be 6-inch diameter perforated/slotted HDPE pipes with double-walled solid (non-perforated) outfalls booted through the secondary geomembrane liner. Each pipe will be pitched to discharge by gravity flow to their respective collection/sampling points, allowing for identification of which section of the impoundment any potential leak occurs in. The perforated/slotted sections of these pipes will be bedded within pea stone. Profiles of
